## ANALYSIS OF JAPANESE NUCLEAR CASUALTY DATA

Final Report  
on  
Contract Nos. OCD-PS-64-196 and N228-(62479)69778  
(Work Unit No. 3411A)

April, 1966

USNRDL-TRC-46

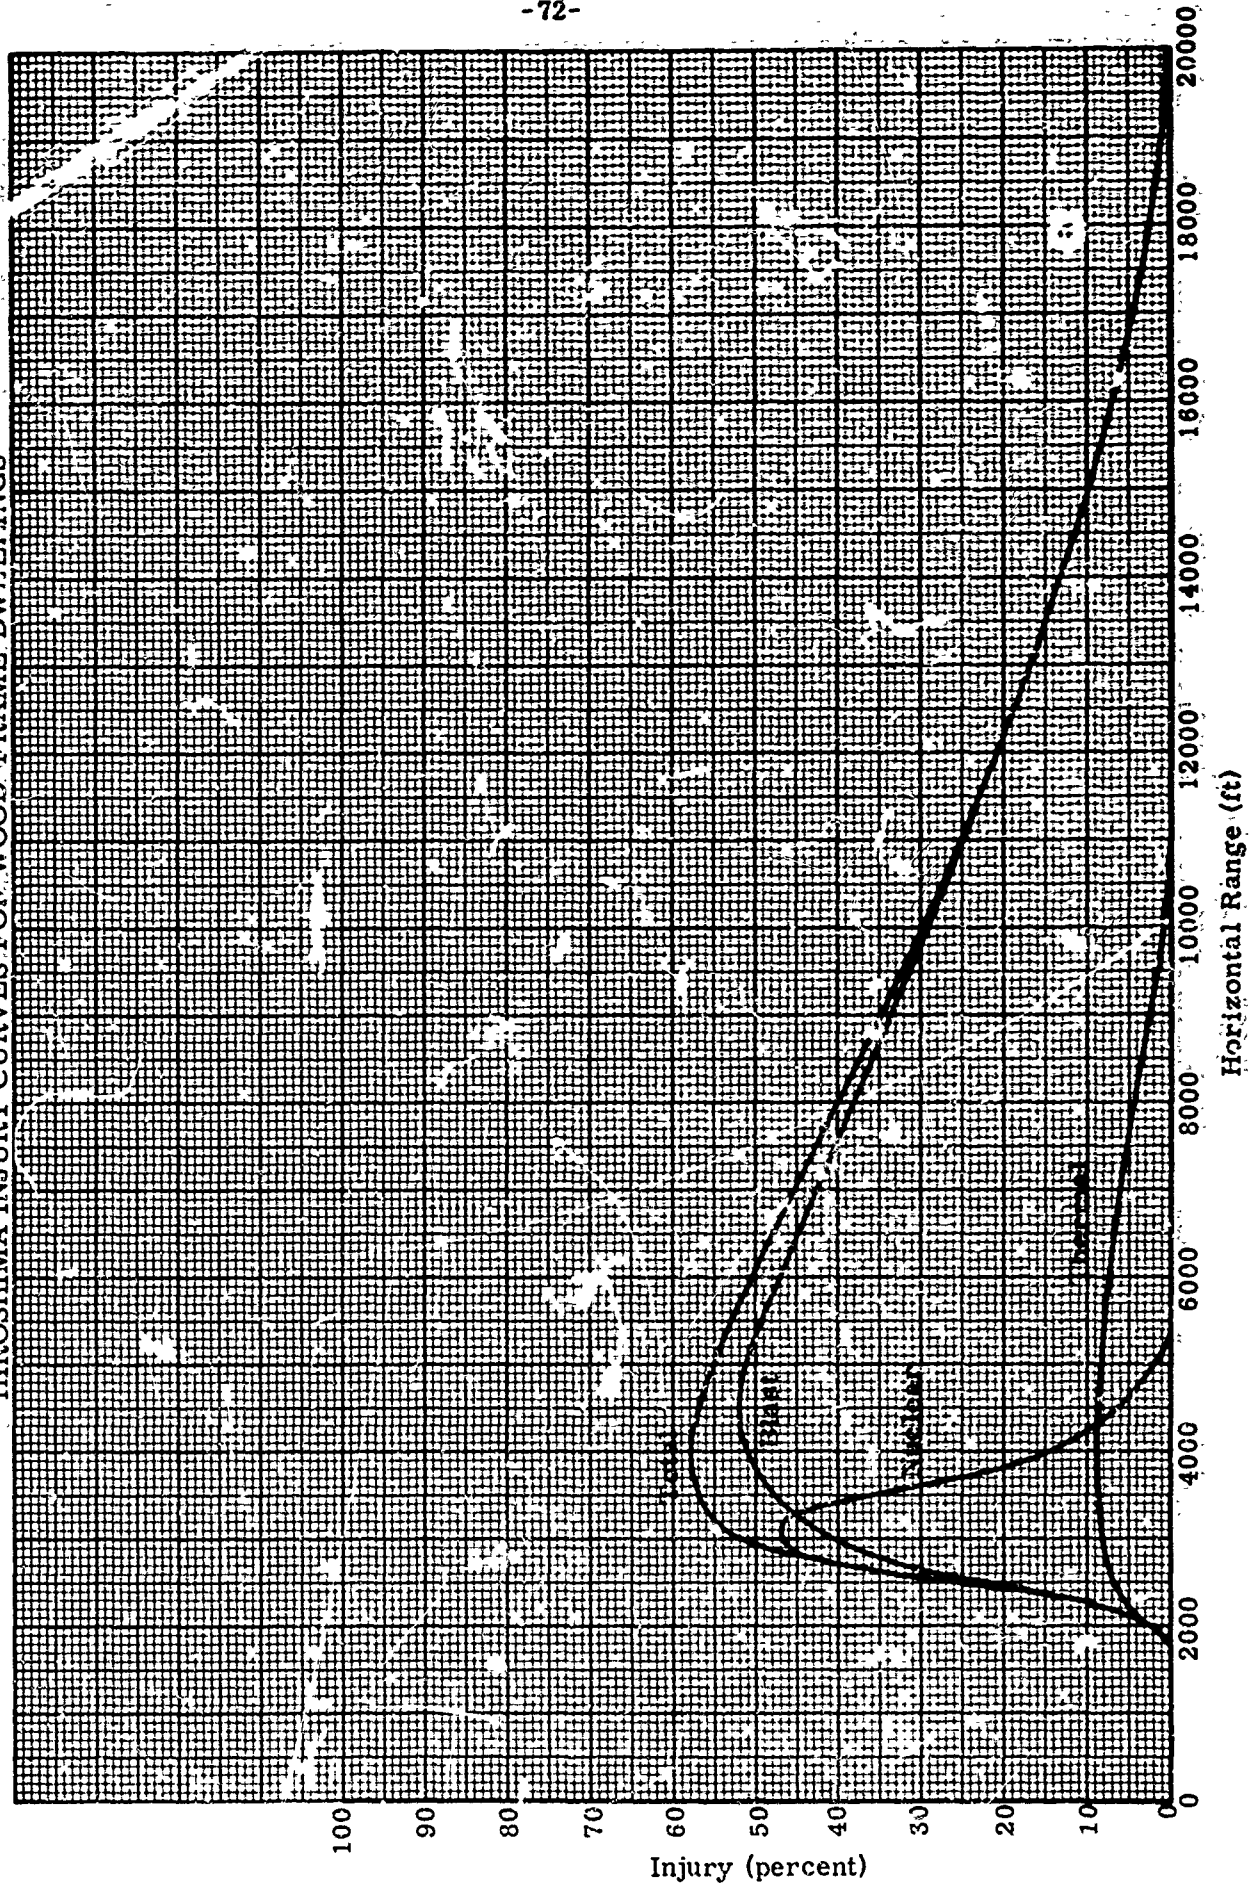
FIG. 46

HIROSHIMA INJURY CURVES FOR WOOD-FRAME DWELLINGS

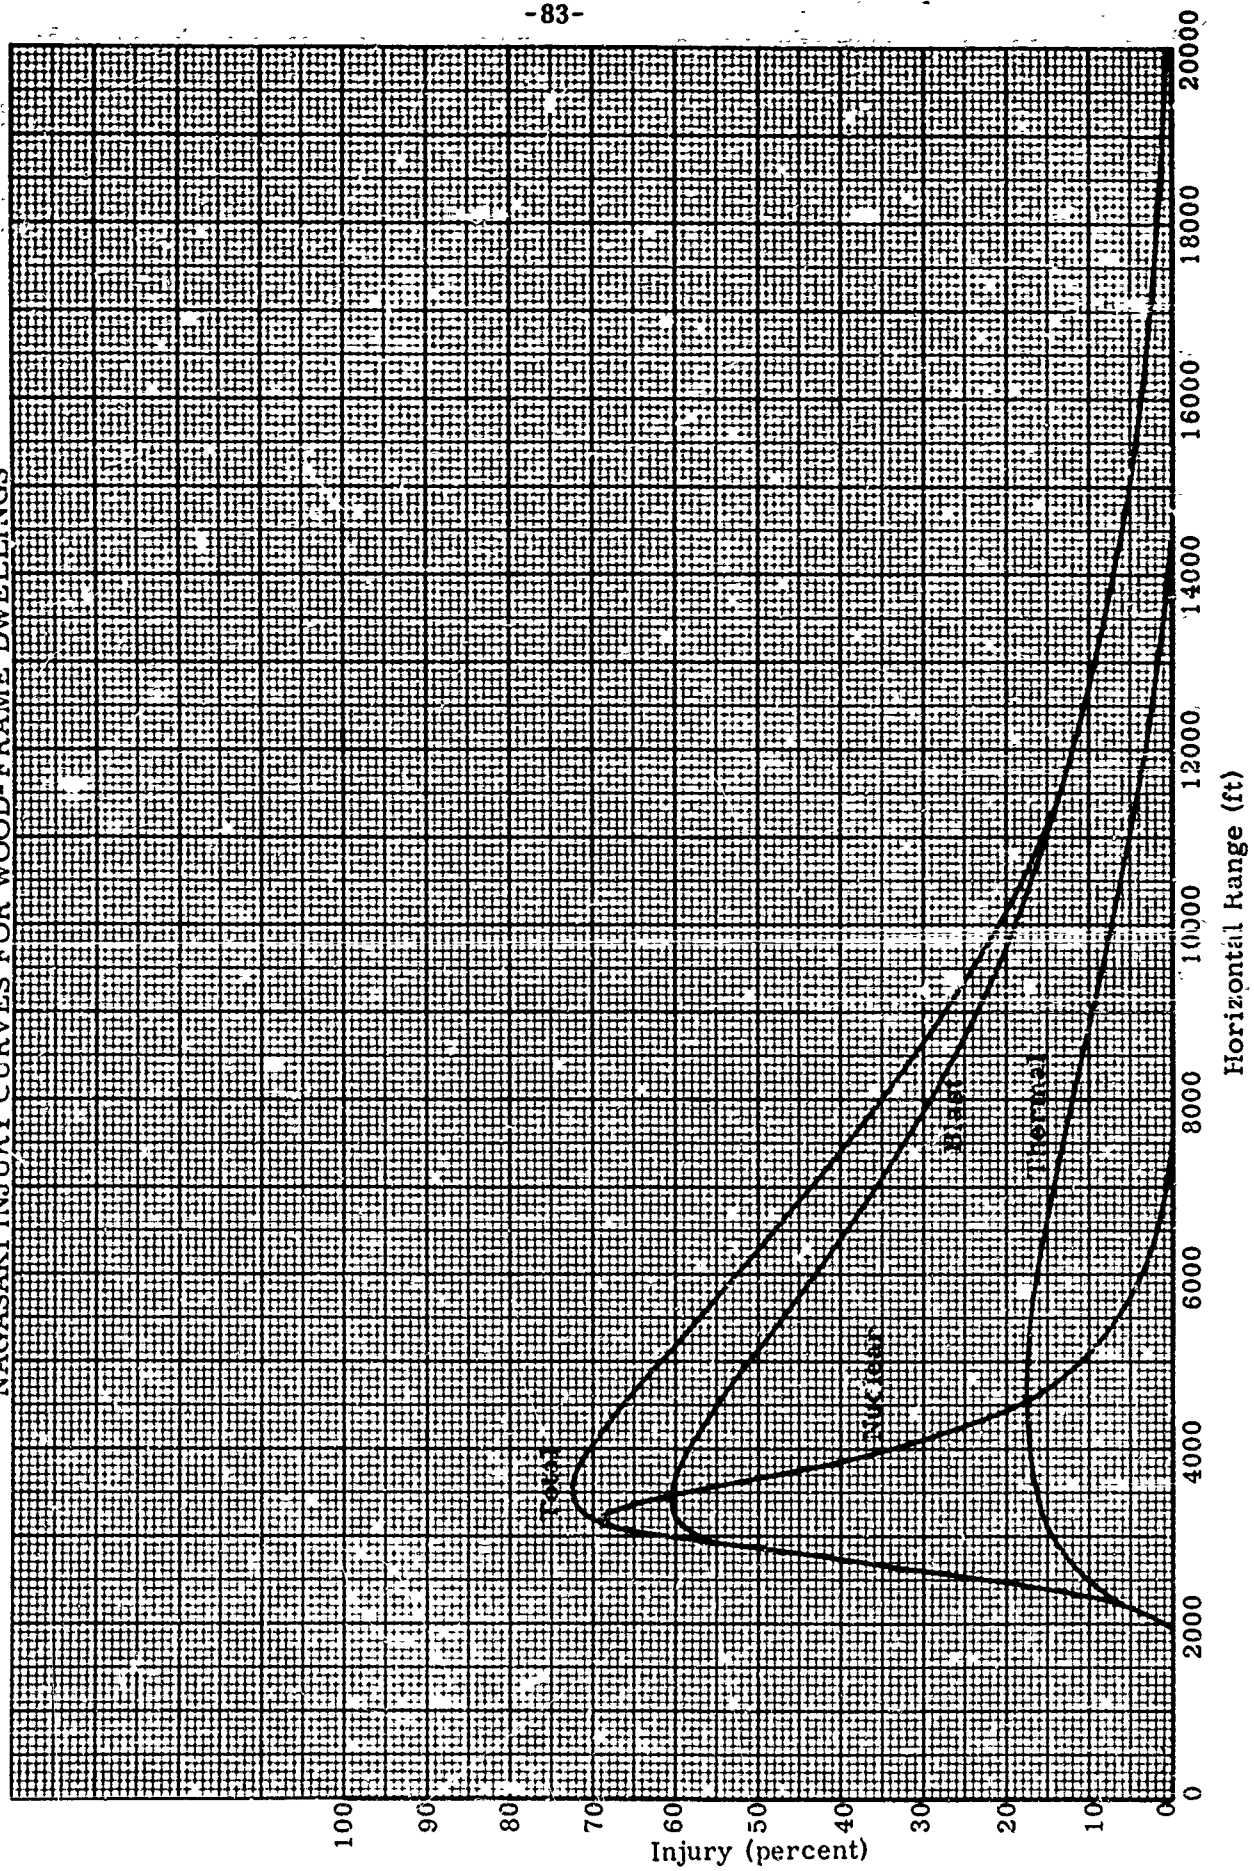
FIG. 57  
NAGASAKI INJURY CURVES FOR WOOD-FRAME DWELLINGS

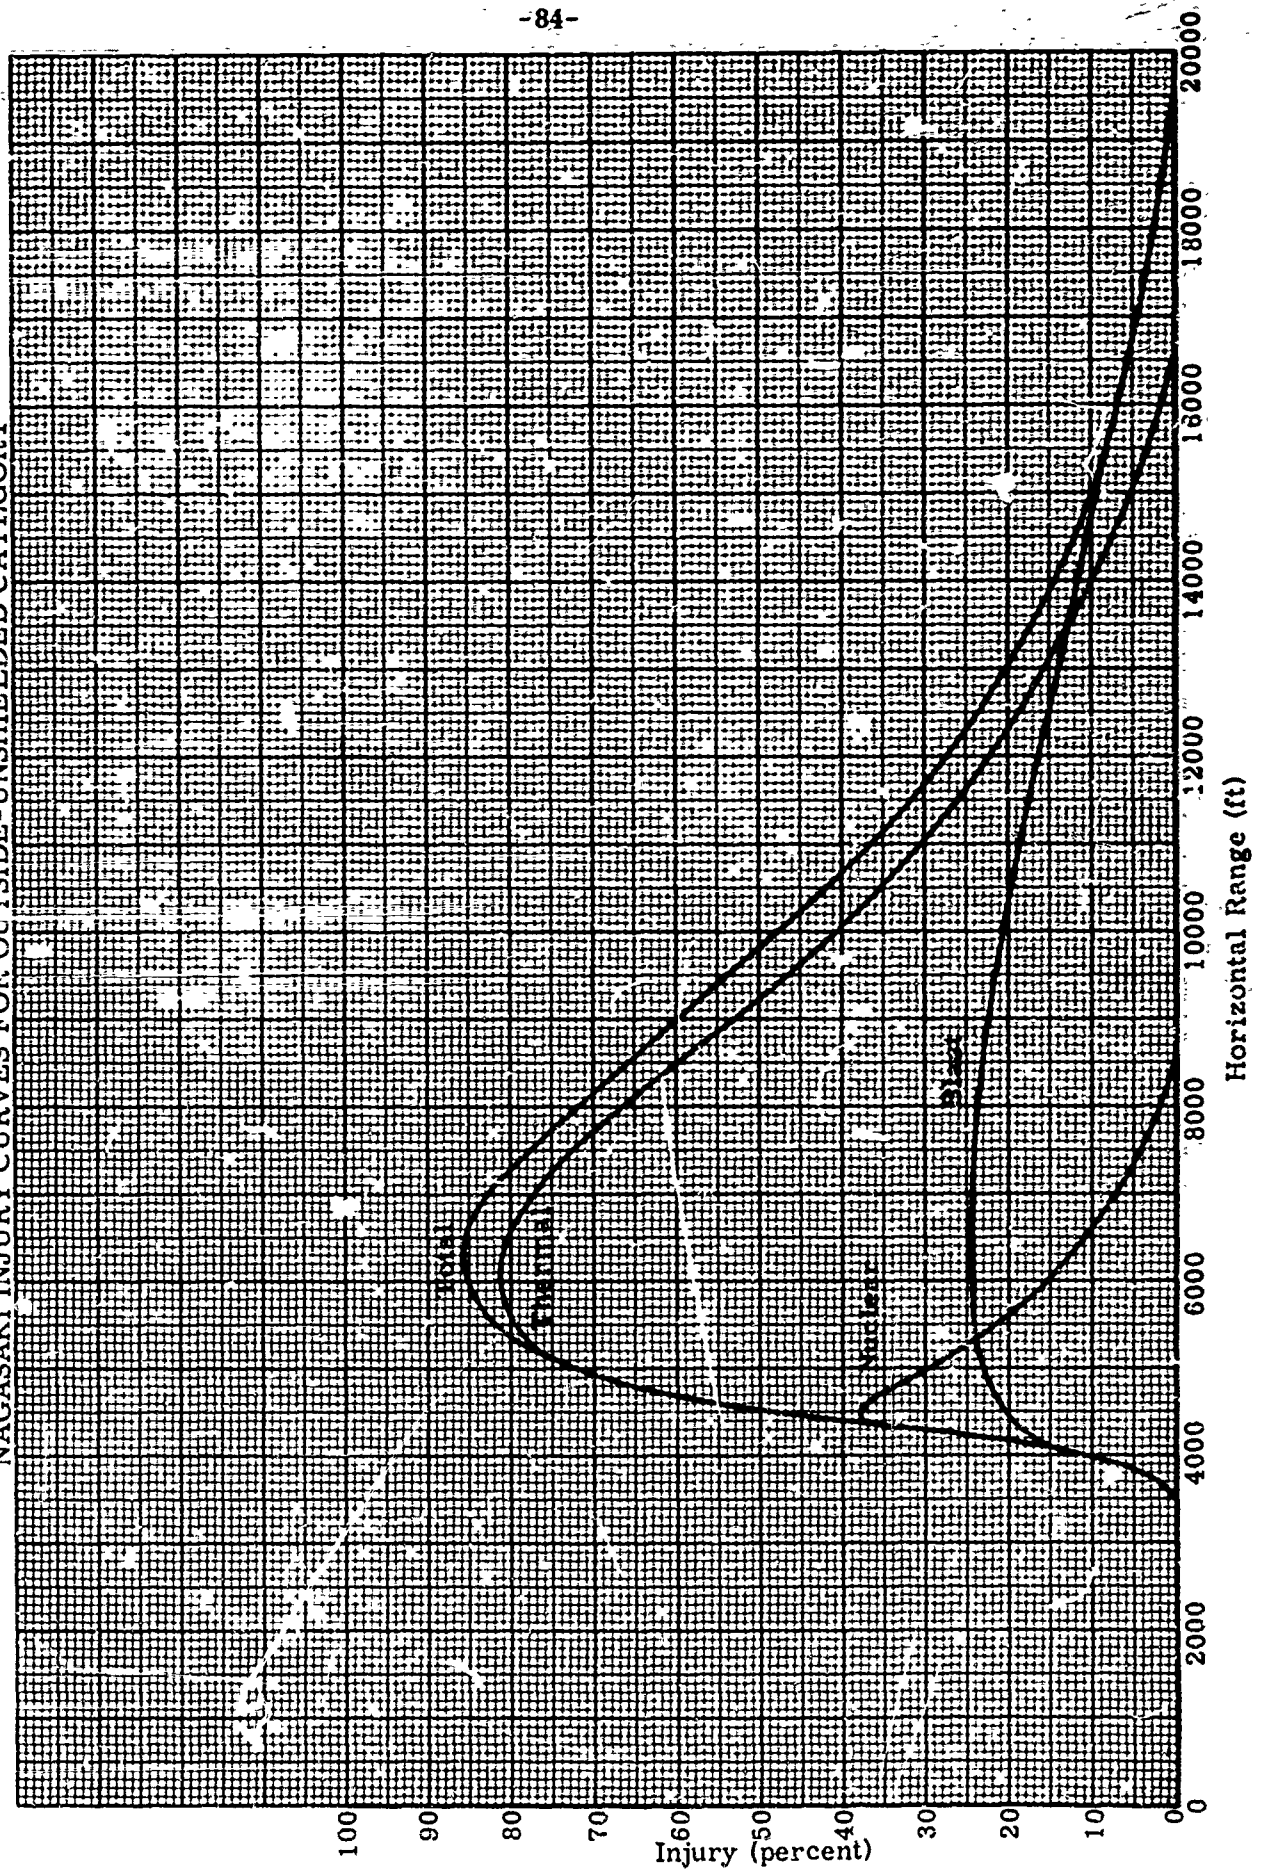
FIG 58

NAGASAKI INJURY CURVES FOR OUTSIDE-UNSHIELDED CATEGORY

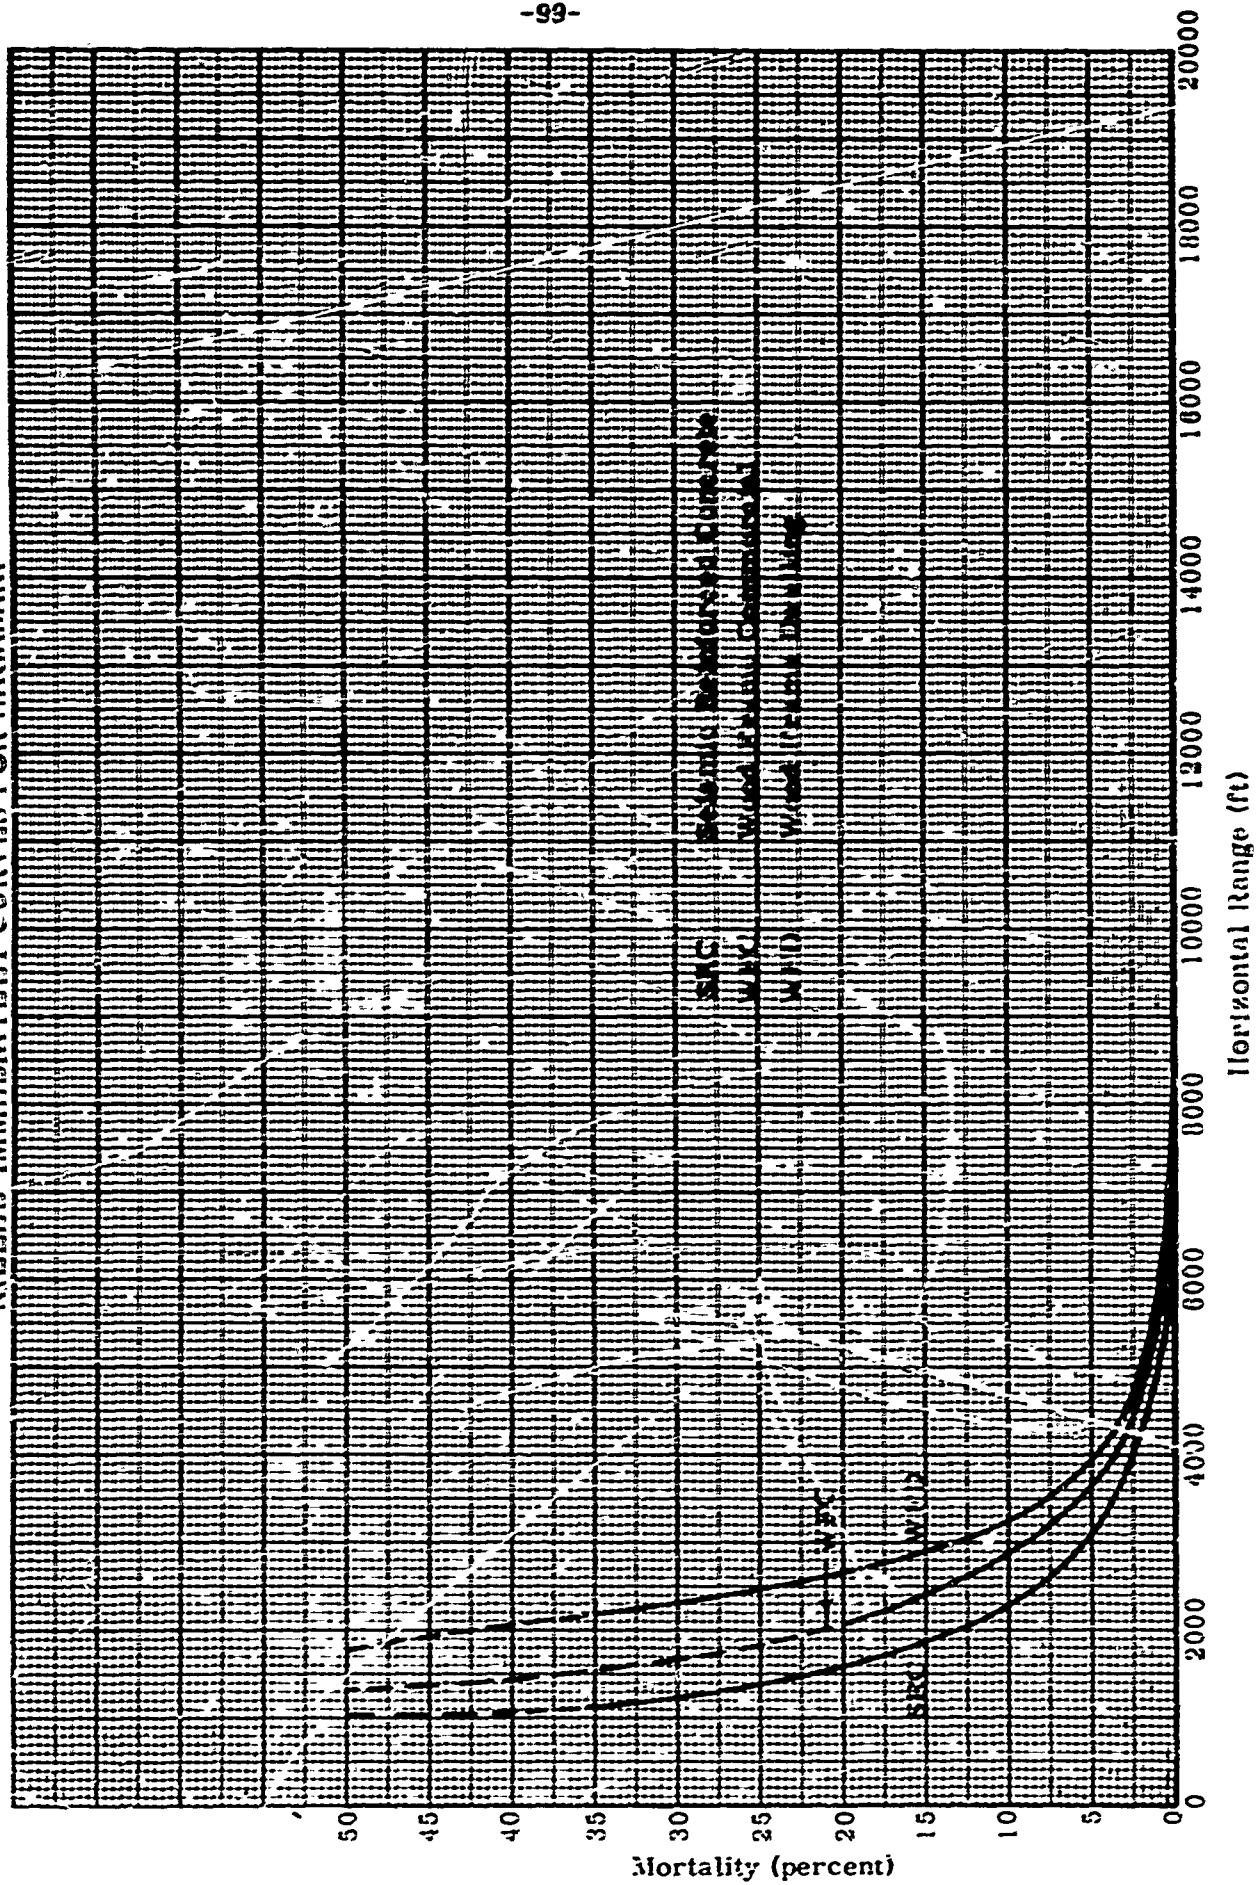
FIG. 60  
KILLED-IMMEDIATELY CURVES FOR NAGASAKI

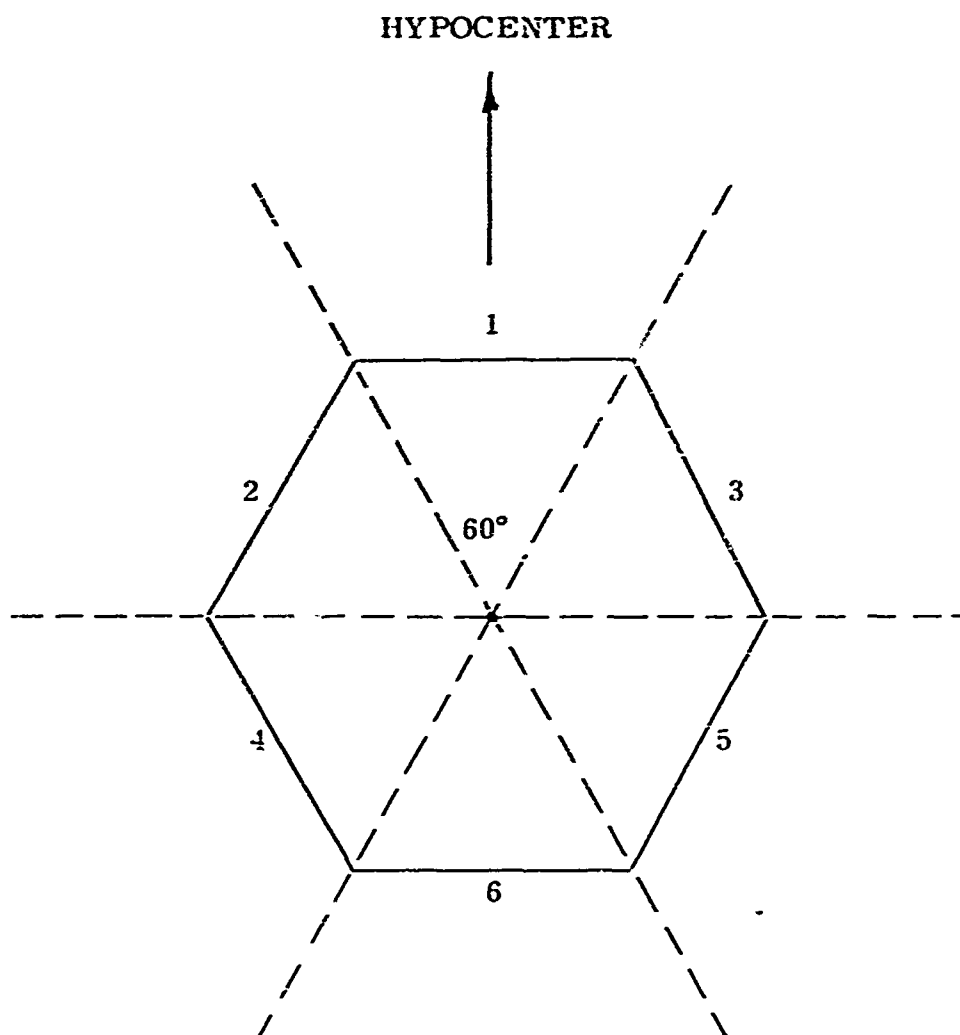
FIG. 67

CODES FOR DIRECTION OF SHELTER OPENINGS

NOTE. Center the model over the shelter with the arrow pointing toward the hypocenter. Select the two radial lines that best define the direction of the shelter opening with respect to the orientation of the model. The number given between the two radial lines selected is the code number to be entered. In case of more than one shelter opening, code the opening nearest the hypocenter.
